Opera Assessment Report Revision 2

Independent Assessment of Eskom's Operational Situation

August 2023

Client:	National Treasury of South Africa	
Project No:	NT015/2022	
Report Title:	Opera Assessment Report – Revision 1	
Report No:	2 NT_Eskom	
Main Authors:	Bartosz Zajda (Dornier) Manswet Banka (Dornier) Klaus Bransch (Dornier) Vladan Dokic (Dornier) Pieter Janse van Rensburg (Dornier) Dr. Thomas von Schieszl (Dornier) Jörg-Schulte Trux (KWS) Ralf Wiescher (KWS) Rainer Zobel (KWS) Axel Meschbiz (RWE) Petros Terzis (RWE)	Volkmar Bobon (STEAG) Dietmar Breuer (STEAG) Dr. Ruth Egyptien (STEAG) Werner Renk (STEAG) Sener Günes (vgbe) Bernhard Michels (vgbe) Dr. Mark Newby (vgbe) Dr. Claudia Stockheim (vgbe) Dr. Oliver Then (vgbe) Dr. Christian Ullrich (vgbe) Dr. Claudia Weise (vgbe)
Date of Issue:	August 2023

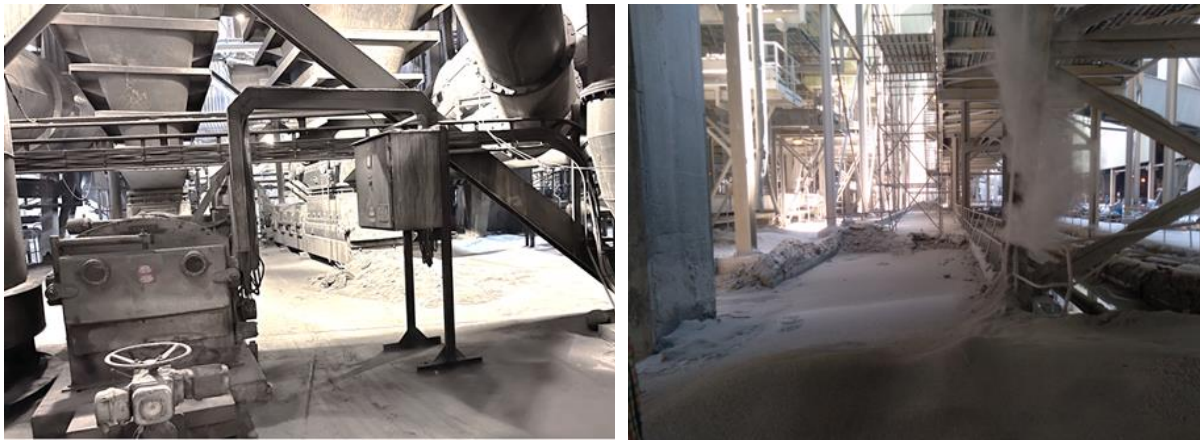
During the visit, the team walked through the boiler house. As shown in Figure 157: Poor housekeeping in Matimba's boiler house, below, housekeeping was poor. High amounts of dust, ash or coal were present.

Figure 157: Poor housekeeping in Matimba's boiler house

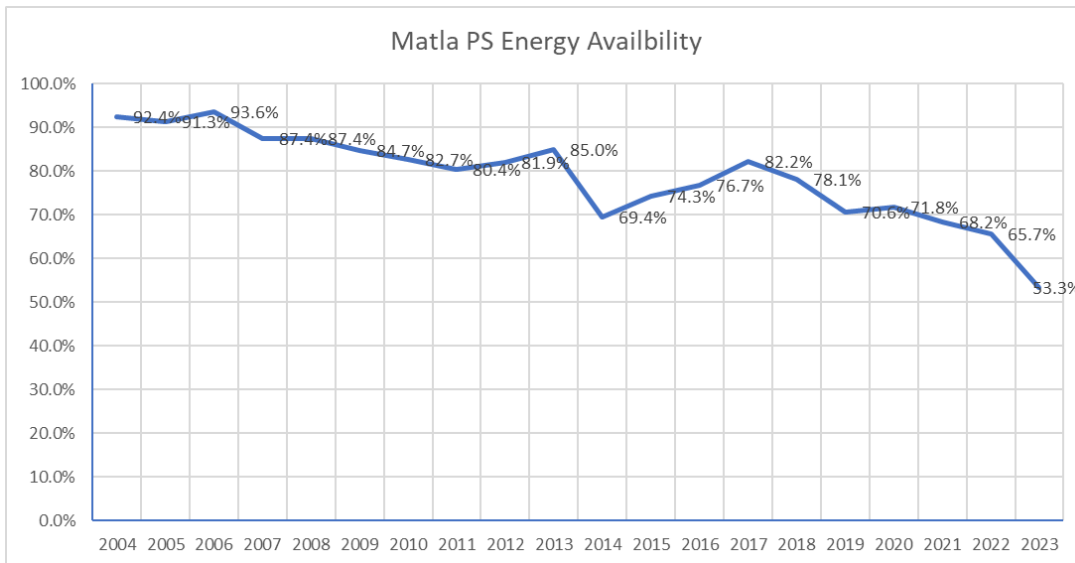
Figure 159. Matla's availability (FY2003/2004–FY2022/2023)

Matla was a very reliable power station until 2013; availability was consistently above 80% with a high of 93.6% in 2006, as Figure 159 shows. In 2014, the availability took a deep dive to 69.4% but then improved again to 82.2% in 2017. However, since 2018 the station EAF has shown a steady deterioration every year, reaching 53.3% by the end of FY2022/2023.

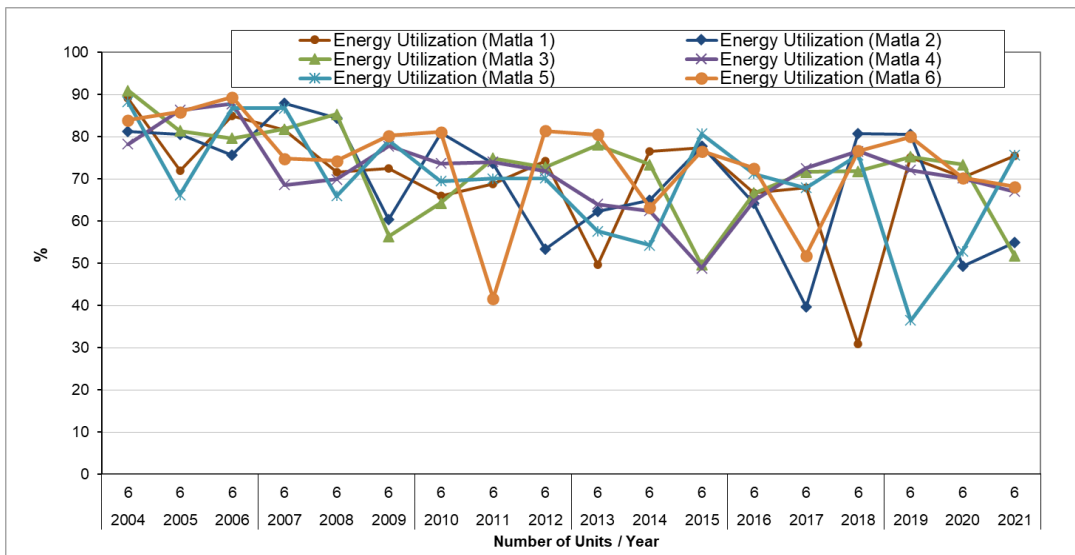
Figure 160: Unit-wise availability and utilization at Matla (FY2003/2004–FY2020/2021)

Figure 160 shows the availability and utilisation of each of the six units at the Matla station for the period 2004 – 2021. The information per unit shows that the availability decline was consistent across all units and not only related to specific units.

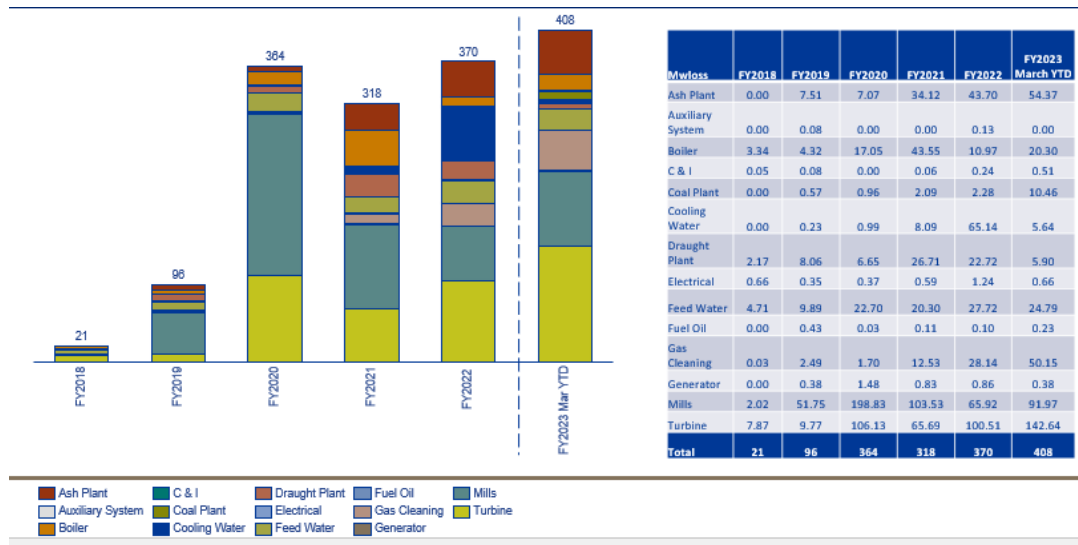
Figure 161: PLL contributors at Matla power plant (2018–2023)
Source: Eskom

The combined PLL and UCLF for Matla was 25.47% for FY2022/2023, with PLL contributing about 46% of the station’s total UCLF losses, which is substantial. For the FY2022/2023, Matla contributed 7% of the total generation fleet PLL and UCLF, which is below average for the fleet at present, but this only highlights how badly the fleet is performing. As Figure 161 shows, MWs lost were 408 MWs during FY2022/2023 and 370 MWs during FY2021/2022. The lost MWs have been increasing steadily since 2018.

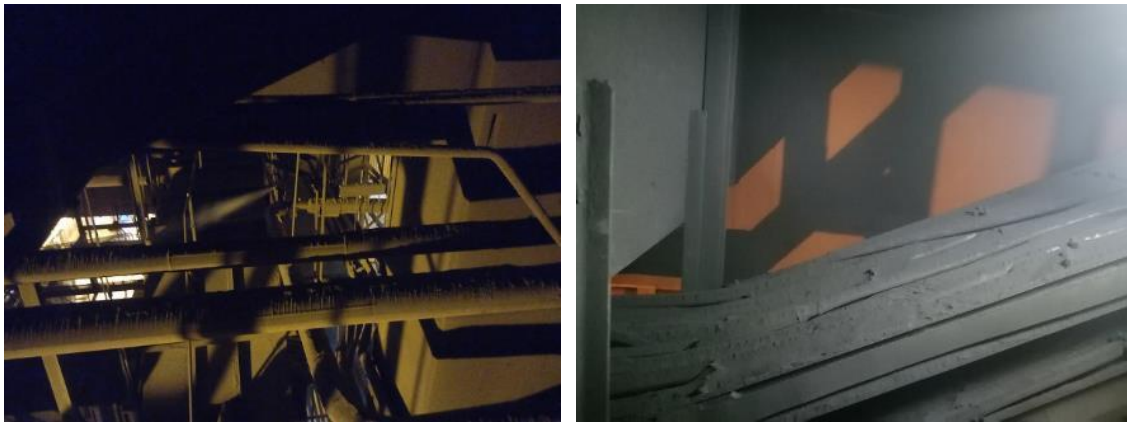
During the visit, the team walked through the **boiler house**. The housekeeping was generally poor in the areas that are not easily accessible to clean and on ground level. Pulverised coal and ash dust was piled up on equipment. This presents a serious fire hazard. The fire in Unit 6 is no surprise and, if housekeeping is not improved, the station will remain at risk. Areas that are easily accessible are generally kept clean (e.g. the mill feeder area at 16m elevation; see Figure 59 and Figure 166). There is high amount of dust and visible pulverised coal leak-ages coming from mill feeder pipes. No other safety-related issues were established.

Figure 165: Coal dust on pipes and cable trays at Matla's boiler house

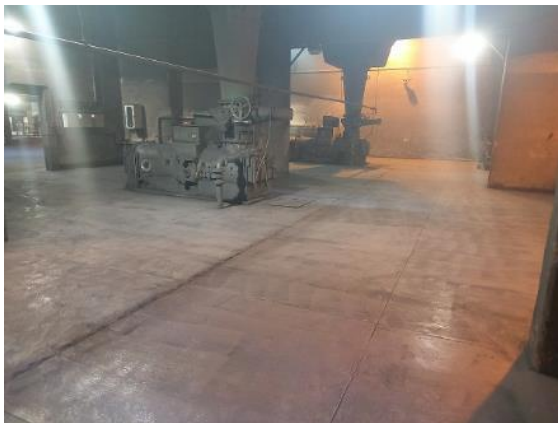
Figure 166: Matla's mill feeder floor at 16m level

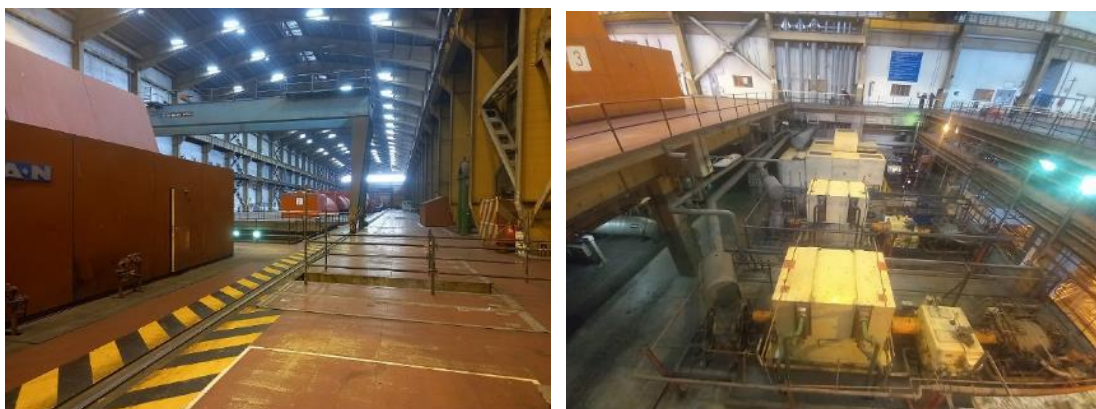
Turbines: MAN impulse-type HP, IP and reaction-type double flow LP, triple-casing condensing turbines have been installed. The turbine hall is reasonably clean. Dust is present on all equipment but is not as bad as some other stations visited.

Figure 171: Turbine hall at Matla power plant

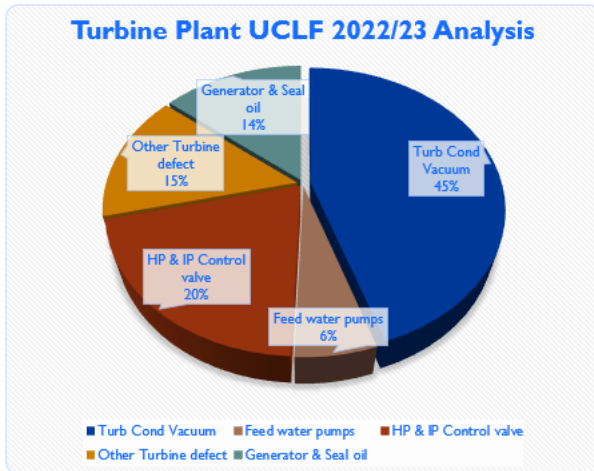
- Turbine plant contributed to a total of 6.54% of total of 32.14 % Matla's UCLF in 2022/23
- Total MW/Hours lost : | 975 482,663

- Summary of UCLF:
 - Condenser vacuum UCLF was primarily driven by poor performance of cooling towers 4-6, and secondly by condenser fouling due to poor CW chemistry
 - Turbine (HP/IP) control valve relates to U3 HP CV3 spindle failure
 - Generator and Seal oil was impacted by unplanned U5 High seal oil flow repairs outage-(worn H2 seals)

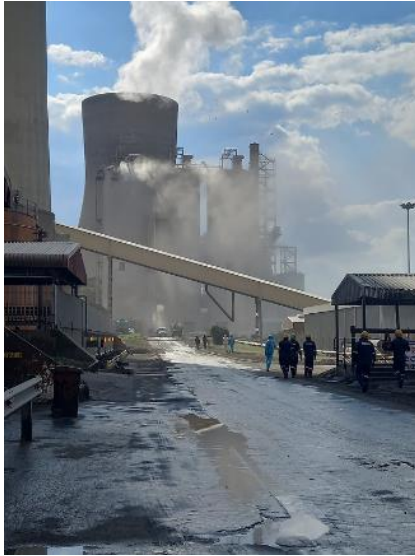
As a result of the addition of the dry dust pilot plant and selling ash to various users, the dust load has actually reduced at the ash plant. However, the particulate control system cannot handle the increased ash volume and does not comply with emission standards; upgrading of the particulate control system is needed. Finally, the ash pump needs maintenance attention.

Figure 175: Dust pilot plant at Matla

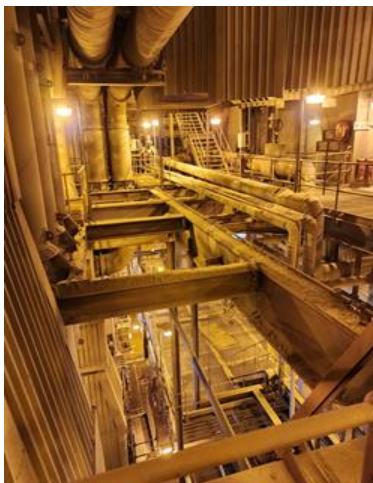
During the visit, the team walked through the boiler house. As shown in Figure 178, Figure 179 and Figure 180, the housekeeping was poor. The plant is equipped to high technical standards but is still in the stabilisation phase, six years after the first unit, Unit 6, was taken over.

Figure 178: Ash accumulation in Medupi's boiler house

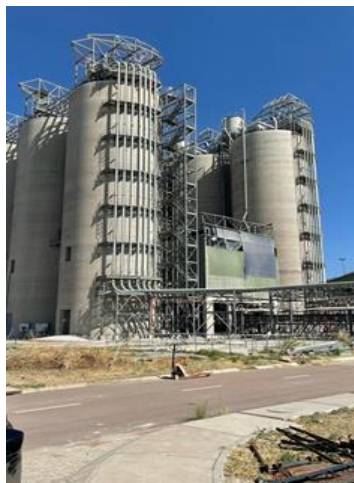
Figure 179: Leakage in silo at Medupi

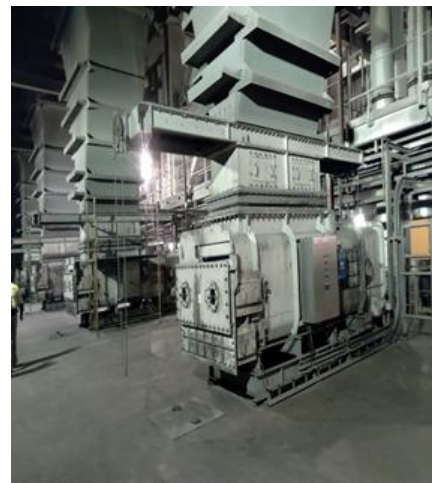
Figure 180: Reasonably clean feeder floor at Medupi

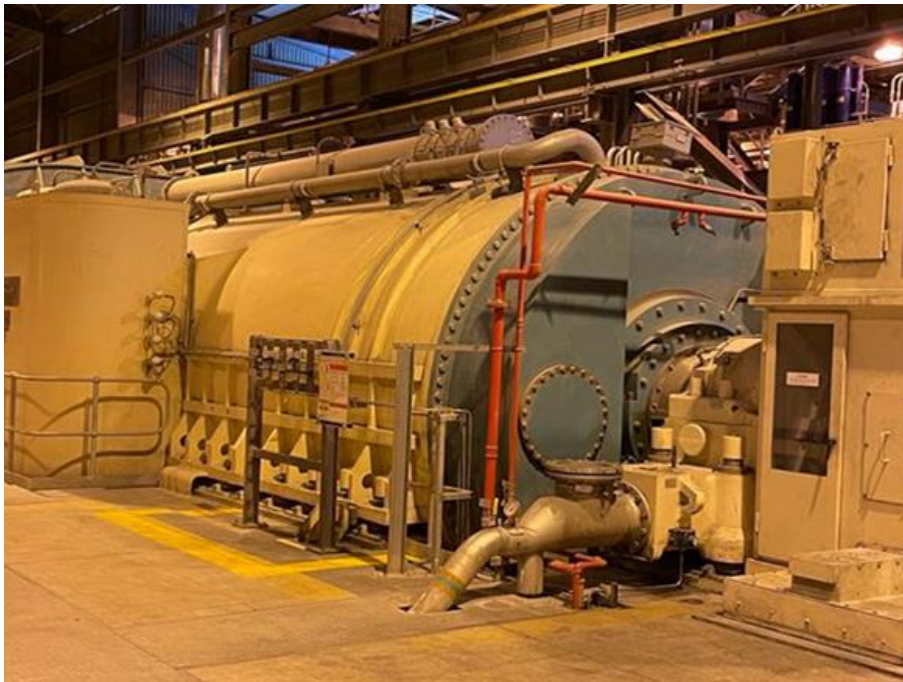
Figure 181: Good housekeeping at Medupi's turbine hall

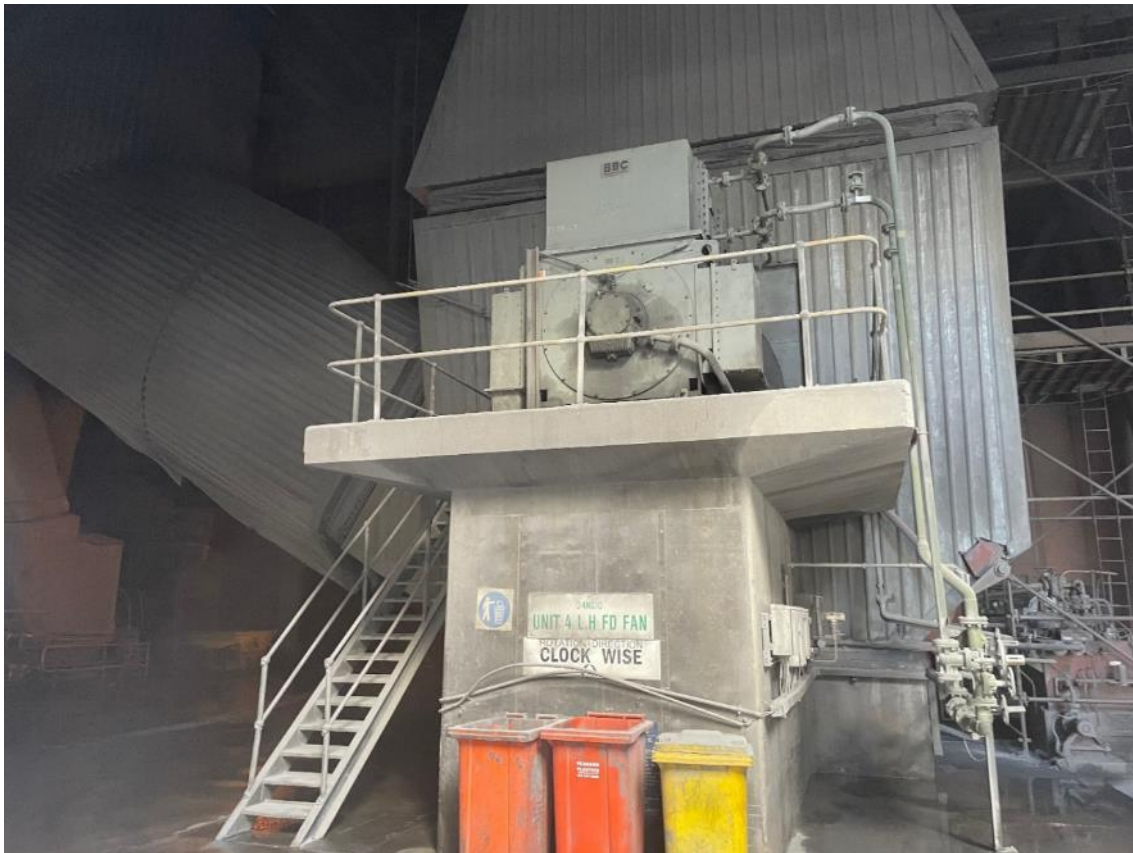
Draught plant: There are two induced-draught (ID) fans per boiler that draw the flue gas out of the boiler to the chimney. At Tutuka plant, the ID-fans have very high vibration levels and are not able to provide sufficient air during full load because of operating with high ash levels in the coal and the malfunction of the electrical precipitator (ash hoppers of the ESP). Furthermore, reducing the air leakages will relieve the ID fan but the problem due to high ash content will remain. One way to fix this problem would be to overhaul and upgrade the ID fans (see Figure 186).

Figure 186: FD fan at Tutuka power plant

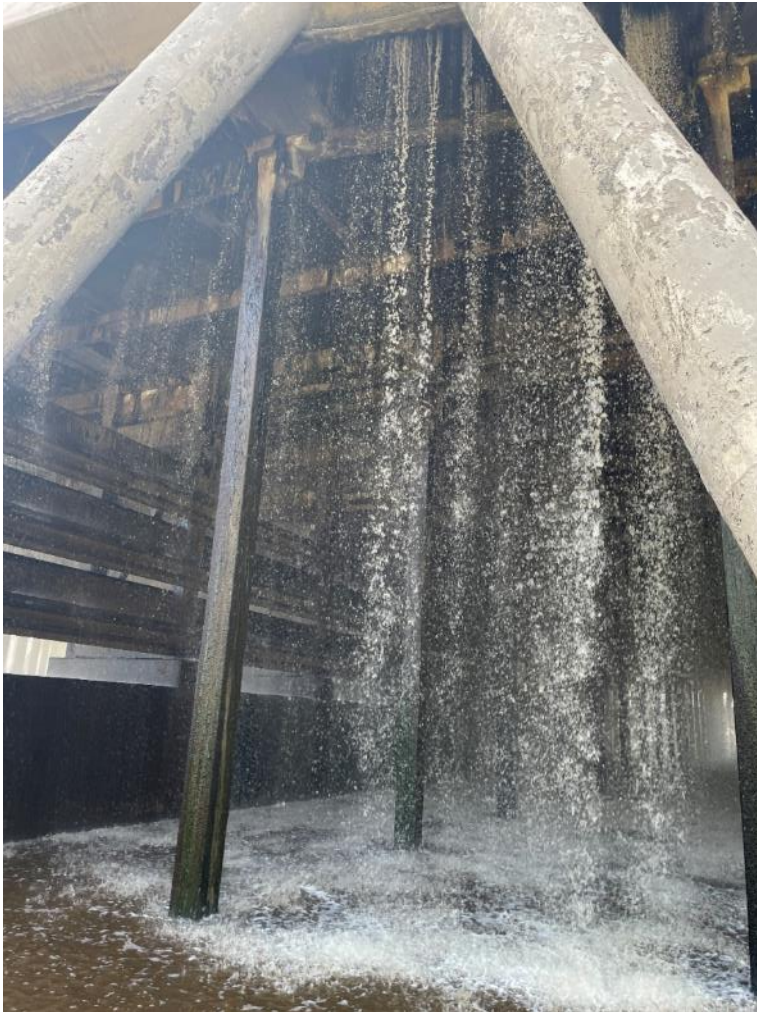
Cooling towers: Another reason for the insufficient condenser vacuum could be the poor performance of four of the six cooling towers. These four cooling towers were in a visibly bad condition: A high content of biofouling was visible on the structures within the towers. During the site visit, only the three cooling towers on the east side were in operation, to support the operation of Units 4 and 5. The underperformance of the towers may be caused by missing and/or damaged end caps within the cooling towers (Figure 188), which has a massive impact on efficiency. The coarse strainers were in good condition but not adequate to ensure good quality of the cooling water, leading to clogged nozzles. The two cooling towers 1 and 6 have already been refurbished and are well maintained. The spray pattern of the refurbished cooling towers was in an excellent condition, in comparison to the other towers. During the visit, cooling towers 1, 2 and 3 were out of operation. Cooling towers 4, 5 and 6 were in operation, with tower 6 accounting for approx. 70% of the cooling performance.

Figure 188: Water distribution and structure of a cooling tower at Tutuka

We recommend the refurbishment of the remaining cooling towers 2, 3, 4 and 5 to overcome the problems and reduce PLL. However, the degree to which the refurbishment would impact PLL also depends on interaction with other necessary plant upgrades. The vacuum problems will continue to impact PLL to the value of about 240MWe.

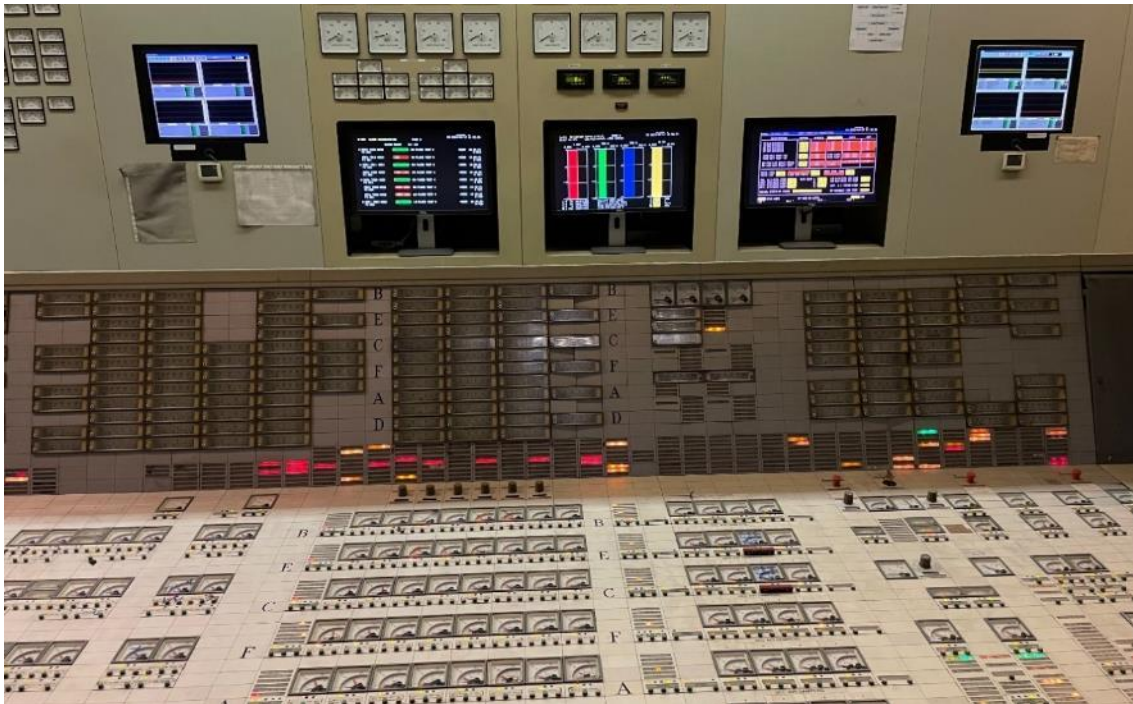
C&I system: With respect to the C&I system, Units 4 to 6 have been modernised with an ABB system and a new control room. Spares are available for these upgraded systems and the systems are still supported by the OEM. The control room and control systems of Units 1 to 3 have not yet been refurbished. As a result, there are still a lot of outdated control elements (Figure 192) and mosaic panel HMI boards (Figure 193) in use. There are no spares available for these old C&I systems. This outdated technology leads to regular unit trips and means a slower return to service afterwards.

Figure 192: Control room for Units 1 to 3 at Tutuka power plant

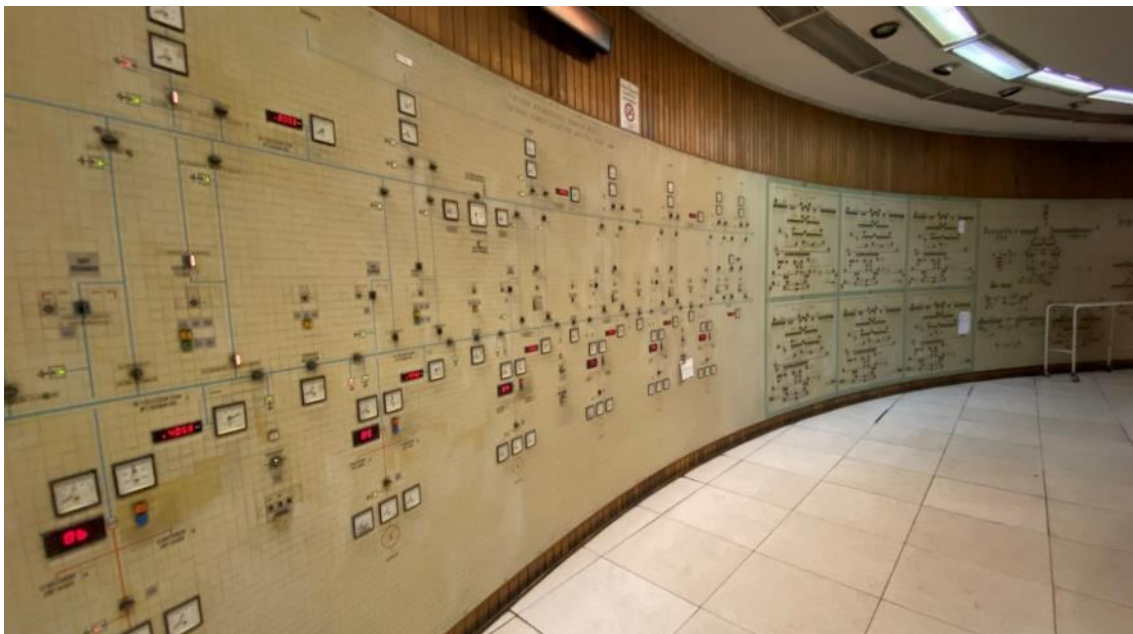
Figure 193: Mosaic panel HMI board at Tutuka power plant

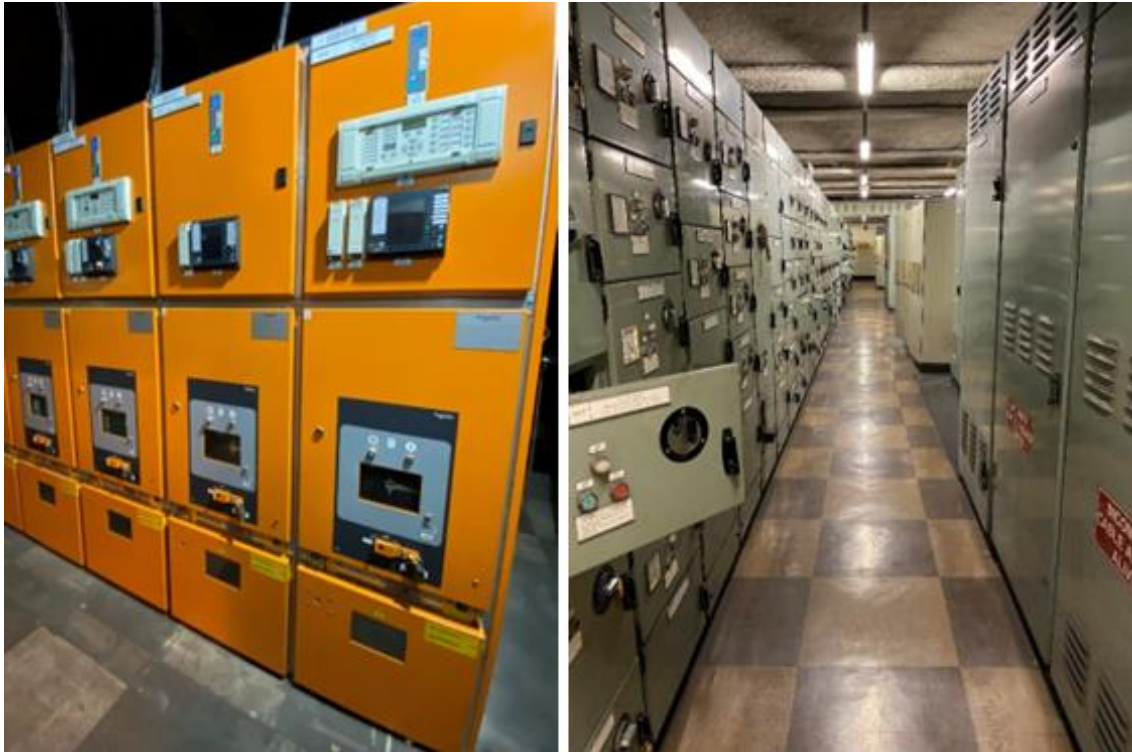
MV & LV Switchgear: The medium voltage switchgear at Unit 6 has been refurbished (Figure 194), but the remaining Units 1 to 5 have not yet been updated and, as such, do not meet international safety standards. The low voltage switchgear has not been refurbished in any of the units so far. During the visit, we came across some open MV board equipment

while construction work was underway nearby. This should be avoided to prevent contamination of internal electrical equipment.

Figure 194: Refurb. MV switchgear (left), non-refurb. switchgear (right) at Tutuka

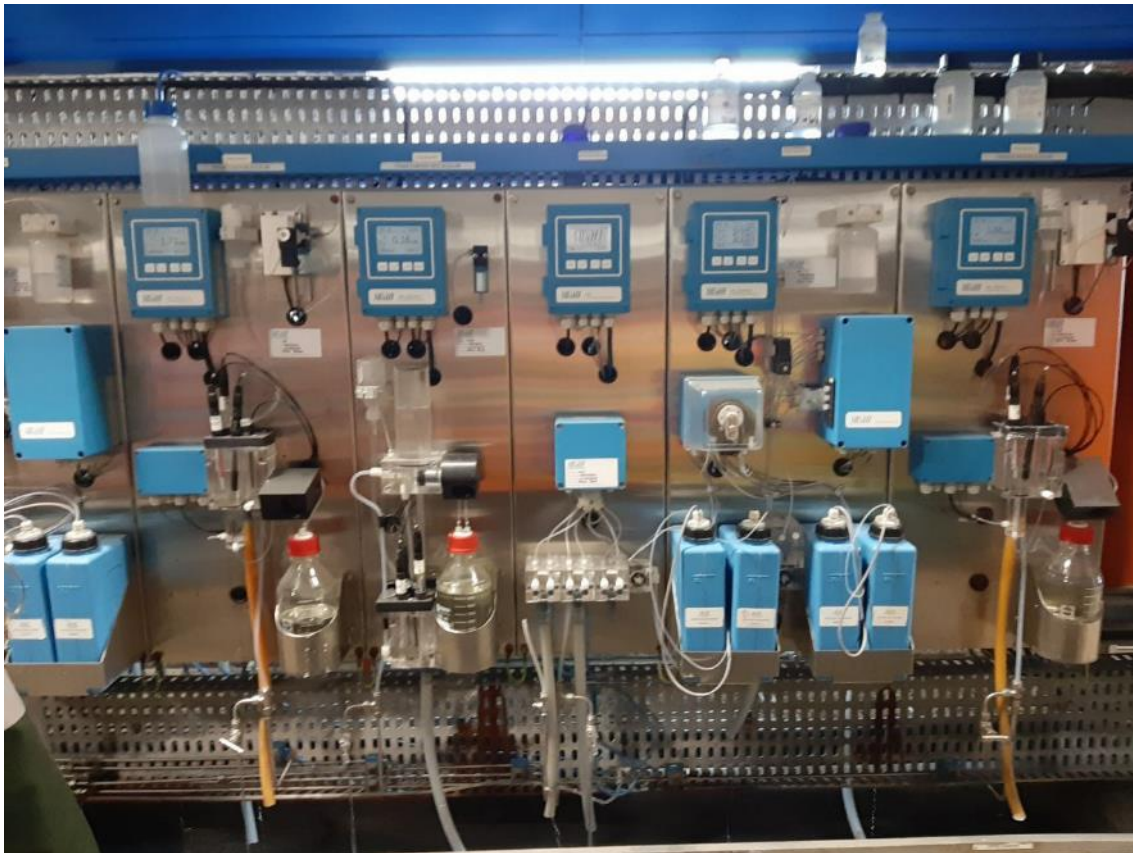
Make-up water plant: The water treatment plant was visited during the site walk. The capacity of the make-up water plant is sufficient to cover the needs of the site and the water quality is acceptable. The water treatment plant was refurbished recently and is in good order (see Figure 195). The water treatment plant's Distributed Control System (DCS) is from Yokogawa and was also installed recently.

Figure 195: Measurements at the Tutuka water treatment plant

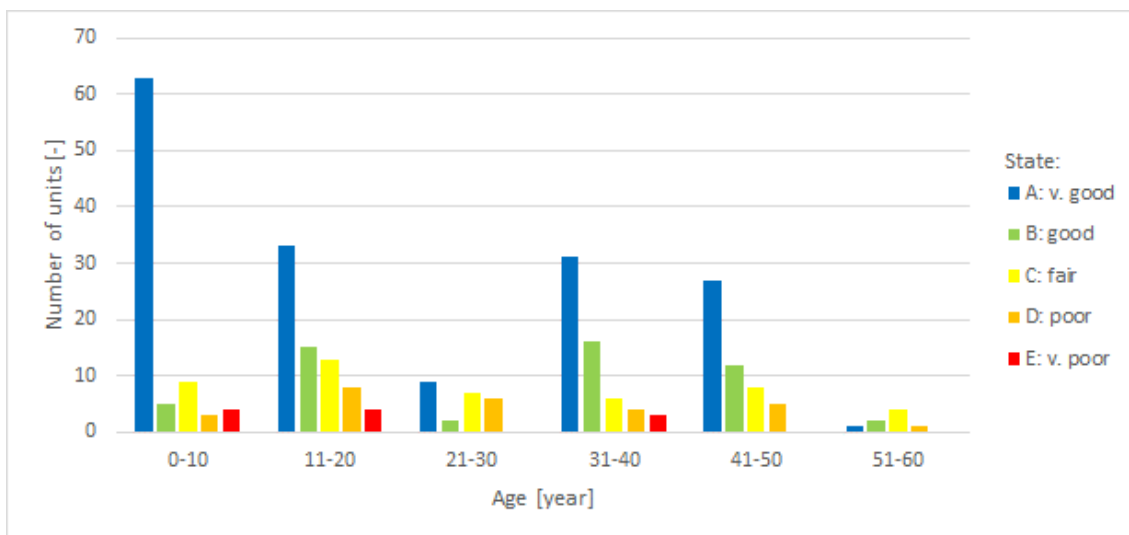
for refurbishment. In the case of transformers, the analysis of gas in oil is the basic criterium for the condition assessment. Figure 204 shows that a large majority of the transmission transformers are in very good condition. Except in the age classes 21–30 years and 51–60 years, the distribution of the results is comparable. It is important to note that even within the youngest class of analysed assets, there are units in very poor condition, and these units should be given more attention. In comparison, none of the units in the oldest age classes (41 years old and older) had critical values in the gas in oil inspection. Nevertheless, the state of the oldest assets can change more rapidly than in the case of younger units, and proper countermeasures should be prepared for such instances. Figure 205 and Figure 206 show that the critical units are distributed almost independently of voltage level and unit capacity. It should be noted that in the group with the biggest transformers (601–800 MVA in Figure 206), the ratio between units rated as “very good” and “fair”, “poor” and “very poor” is the lowest.

Figure 204: State classes of Eskom trans. transformers (≥132 kV) dep. on the age

Condition-based refurbishment is the state-of-the-art assessment method, and it is recommended to continue with this approach. When preparing for the refurbishments, plans need to take into consideration the fact that the degradation of the older units can accelerate and, due to the age structure, multiple units could require refurbishment at the same time.

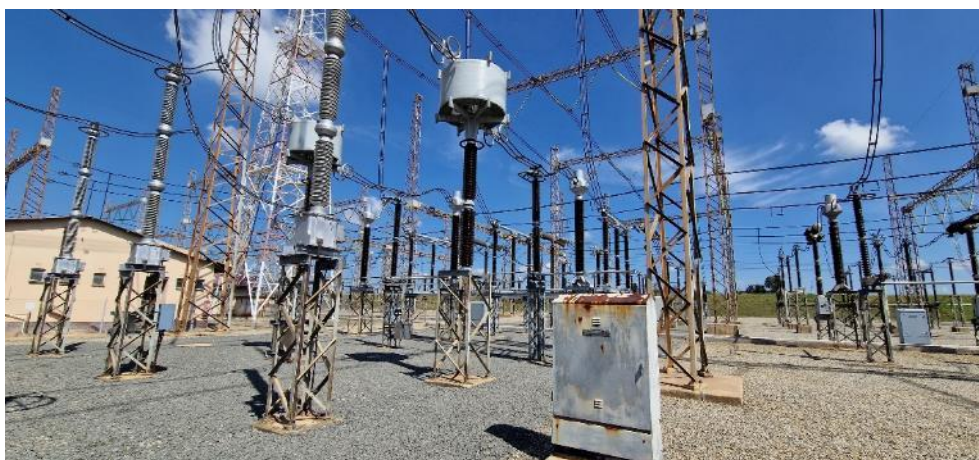
Figure 220: 400 kV switchgear substation Minerva

Activity class of switchgears classification 1,86: Age-related wear and tear, slight signs of rust on steel structures, equipment has been partially replaced by new equipment, no urgent measures required, modernisation must be continued in the medium term (see Figure 220).

- Large part of circuit breakers is replaced by SF₆-circuit-breakers. AC classification 2 – Old low-oil circuit breakers should also be replaced.
- Large part of the disconnectors is replaced by new ones. AC classification 2 – Old disconnectors should also be replaced in medium term.
- Large part of instrument transformers is replaced by new ones. AC classification 2 – Old instrument transformers should also be replaced in medium term.
- Conductor ropes are slightly corroded due to age. AC classification 1 – Age-related wear and tear, refurbishment measures are not necessary.
- Steel construction slight signs of rust. AC classification 2 – Age-related wear and tear, refurbishment measures are not necessary.

- Basements with some tear and wear. AC classification 2 – Age-related wear and tear, refurbishment measures are not necessary.
- Groundings visually inspected at random, slight visual signs of wear. AC classification 2 – Age-related wear and tear, refurbishment measures are not necessary.

Due to its age, the switchgear shows wear and tear. Major components have been replaced with new equipment. Due to the excellent maintenance of the switchgear, it is fully functional despite its high operating age. Further modernisation measures are to be carried out in the medium term (see Figure 221).

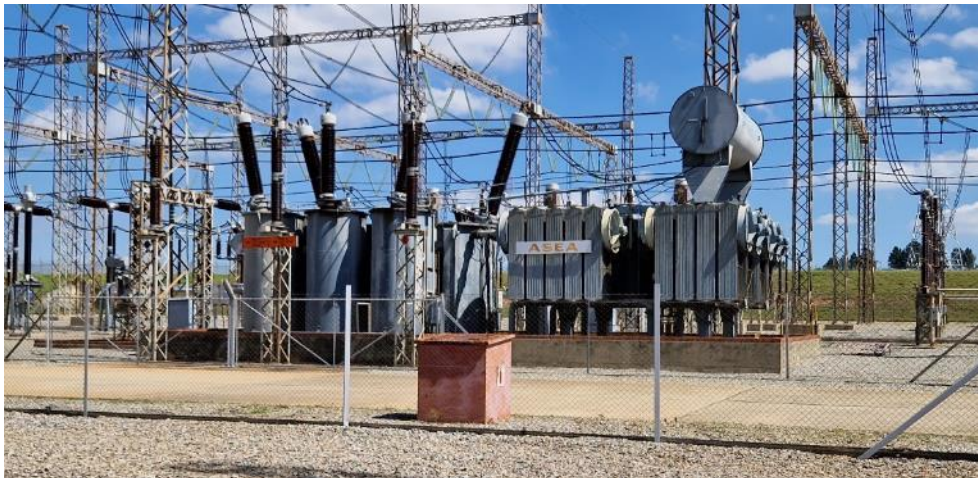
Figure 222: Power Transformer in substation Minerva

Activity class of Power Transformers (in operation between 1982 and 2009) classification 1,44: Age-related wear and tear. The oil leakage of transformer 4, which has been in operation since 1982, must be monitored. In the case of the relatively new transformers 1 and 2, the comparatively poor values of the gas-in-oil analysis can still be observed. If the values continue to deteriorate, replacement/repair may have to be considered. Condition without findings, no measures necessary (see Figure 222).

- General impression of inspection: AC classification 2 – Age-related wear and tear, refurbishment measures are not necessary.
- Gas in oil analysis (all four transformers last test of 09.12.2022, TRFR1 and 2 D poor, TRFR 3 C fair, TRFR 4 A very good). AC classification 2 – Age-related wear and tear, monitoring of Gas in oil analysis results.

- Bushings, AC classification 1 – Age-related wear and tear, refurbishment measures are not necessary.
- Tank, AC classification 2 – Age-related wear and tear, refurbishment measures are not necessary.

- Oil leakage, AC classification 2 – Age-related wear and tear, refurbishment measures are not necessary.
- Fire protection walls, AC classification 1 – Age-related wear and tear, refurbishment measures are not necessary.

- Groundings randomly inspected. AC classification 1 – Age-related wear and tear, refurbishment measures are not necessary.
- Steel construction, radiators etc., AC classification 1 – Age-related wear and tear, refurbishment measures are not necessary.

- Basement, oil leakage sump. AC classification 1 – Age-related wear and tear, refurbishment measures are not necessary.

No refurbishment measures are currently required for the transformers. The poor gas-in-oil analysis results of the relatively new transformers 1 and 2 must be monitored. Cleanliness and maintenance conditions are excellent (see Figure 223).

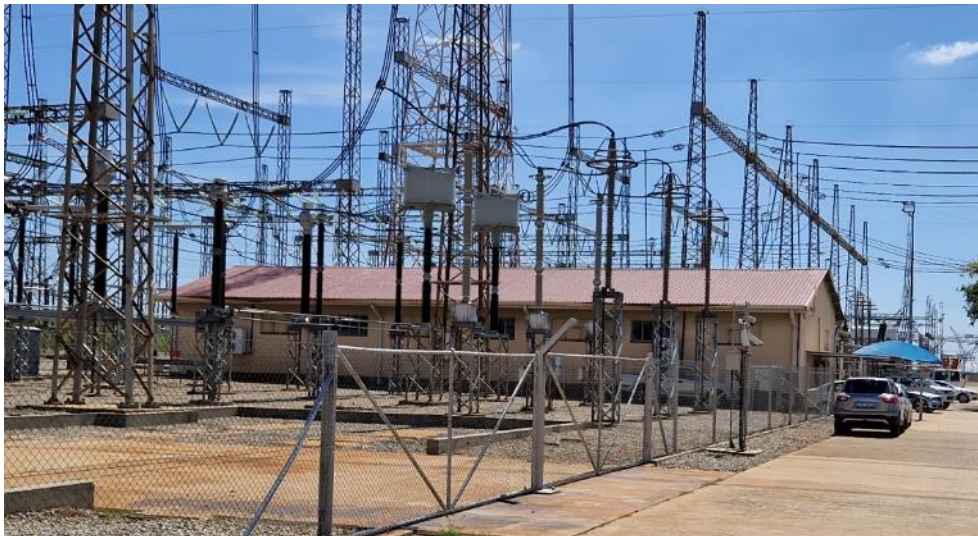
Figure 224: Operation building substation Minerva

Activity class of the operation building, classification 1,21 – Slight wear due to age, condition without findings, no measures necessary (see Figure 224).

- Outside general impression of inspection, AC classification 2 – Slight wear due to age, condition without findings.
- Roof visual inspection from the ground, AC classification 1 – condition without findings.

- Walls, AC classification 1 – condition without findings.
- Basement, AC classification 1 – condition without findings.
- Surface, AC classification 2 – Slight wear due to age (dusty), condition without findings.
- Waterproofing visual inspection, AC classification 1 – condition without findings.
- Lightning protection visual inspection from the ground, AC classification 1 – condition without findings.
- Inside general impression of inspection, AC classification 1 – condition without findings.
- Emergency exits, place for exit, AC classification 1 – condition without findings.
- Ventilation, AC classification 1 – condition without findings.
- Illumination, AC classification 1 – condition without findings.
- Cleanness, AC classification 1 – condition without findings.

Despite its many years of use, the operation building is in excellent condition. Cleanliness and maintenance condition are excellent (see Figure 225).

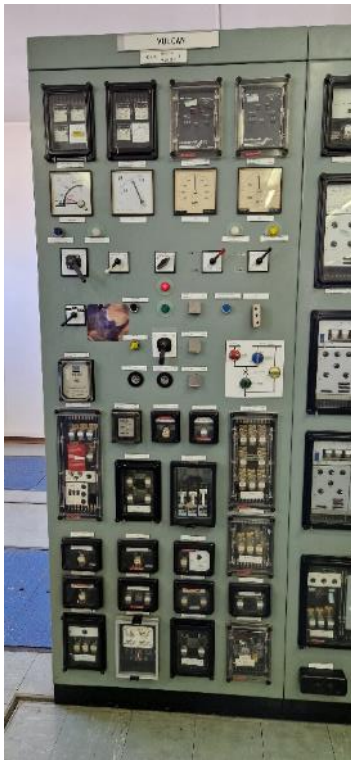
Figure 226: Example of protection/control cabinet substation Minerva

Activity class of Secondary Technology, classification 1,5: Some switch panels have already been renovated in terms of secondary technology. The majority are still equipped with old electromechanical protection technology. This is no longer state of the art and should be replaced in the medium term (see Figure 226).

- SCADA Connection to Control Centre available, AC classification 1 – Partly modernised, further modernisation required in the medium term.
- Protection relays are partly digital, AC classification 2 – further modernisation required in the medium term.

A high percentage of the secondary technology is still electromechanical. With further modernisation around primary technology, the devices of the secondary equipment are also to be replaced by modern digital technology. Cleanliness and maintenance condition are excellent (see Figure 227).

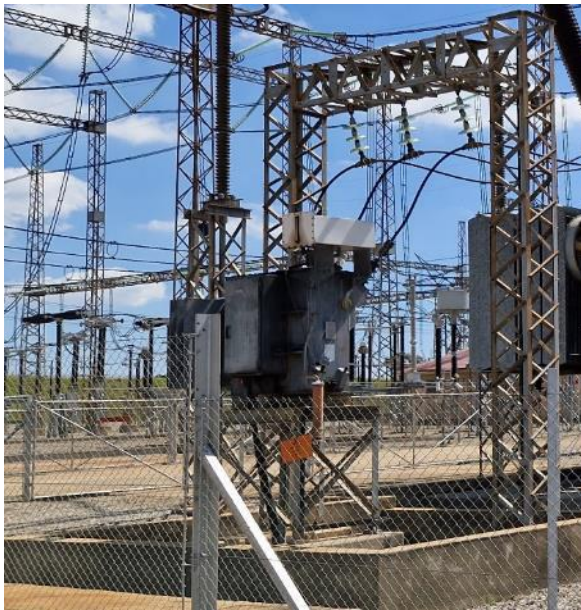
Figure 228: Auxiliary transformer substation Minerva

Activity class of AC/DC systems, classification 1,33: Age-related wear and tear, partly renewed (see Figure 228).

- AC system including auxiliary transformers and AC-distribution, AC classification 1 – Age-related wear and tear, partly renewed, no measures required.
- DC-distribution, AC classification 1 – Age-related wear and tear, partly renewed, no measures required.
- AC/DC converters, AC classification 1 – Age-related wear and tear, partly renewed, no measures required.

The AC/DC systems are in very good condition for their operation age. Cleanliness and maintenance condition are excellent (see Figure 229).

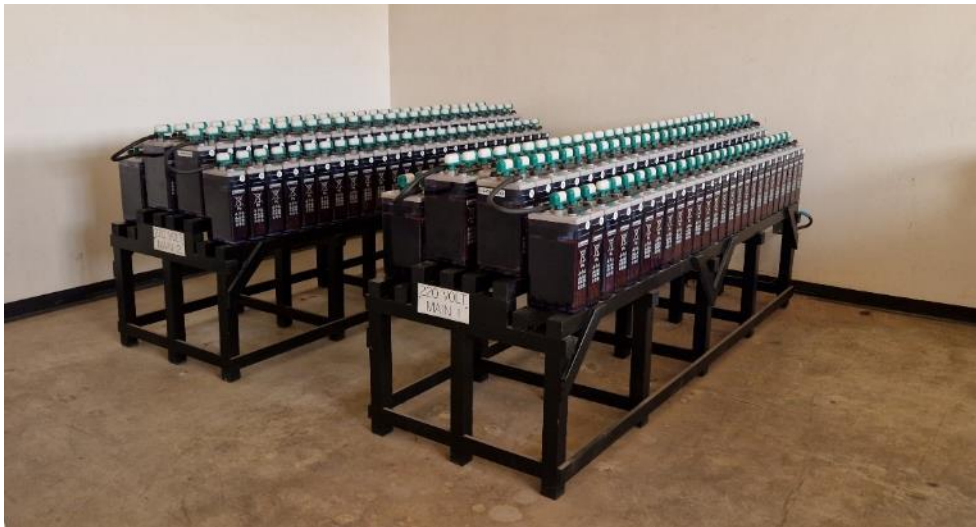
Figure 230: 220 V Battery substation Minerva

Activity class of battery systems, classification 1 – condition without findings, no measures necessary (see Figure 230).

- 220 V Batteries AC classification 1 – condition without findings
- 50 V Batteries AC classification 1 – condition without findings

The battery systems were renewed cyclically during operation. The current status corresponds to the state of the art. Cleanliness and maintenance condition are excellent (see Figure 231).

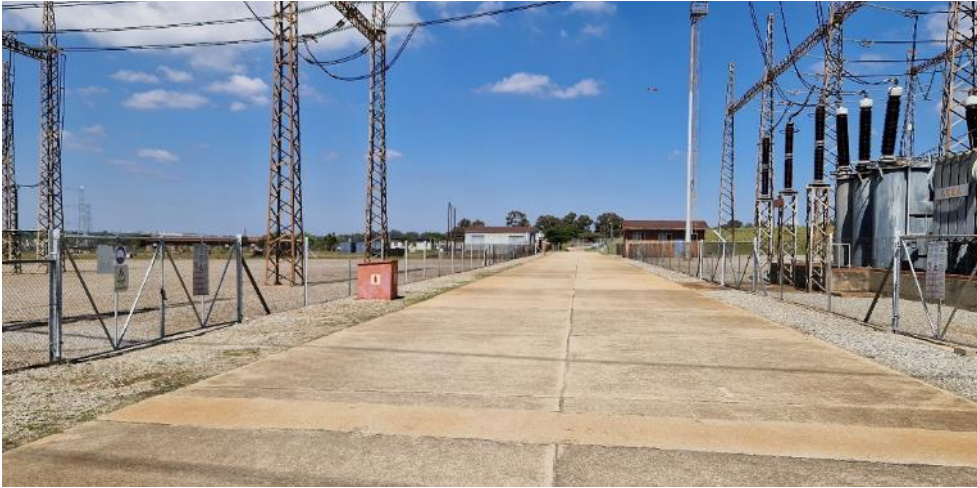
Figure 232: Transportation street and fences substation Minerva

Activity class of streets, footpaths and fences, classification 1,33: Age-related wear and tear but in a very good state of maintenance (see Figure 232).

- General condition, AC classification 2 – Age-related wear and tear, no measures required.
- Fences and security, AC classification 1 – Age-related wear and tear, no measures required.

- Dimensioning, AC classification 1 – Age-related wear and tear, no measures required.

The streets, footpaths and fences are in good condition. No measures are required. Cleanliness and maintenance condition are excellent (see Figure 233).

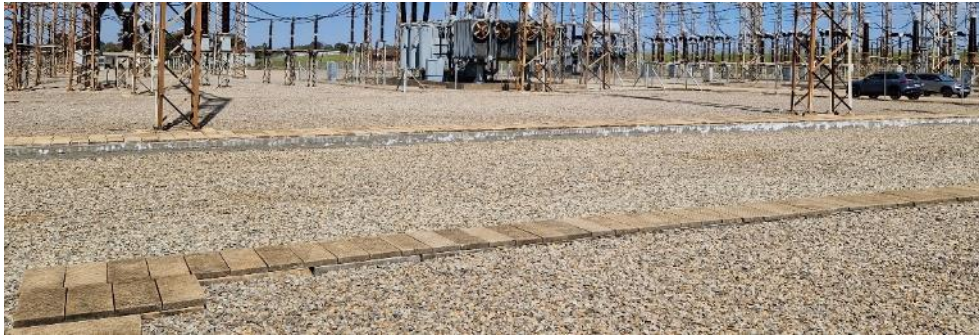
Figure 234: Example of cable duct substation Minerva

Activity class of cable ducts, classification 2: Age-related wear and tear but in a very good state of maintenance (see Figure 234).

- Ducts, AC classification 2 – Age-related wear and tear, no measures required.
- Covers, AC classification 2 – Age-related wear and tear, no measures required.
- General condition, weathering, AC classification 2 – Age-related wear and tear, no measures required.

The cable ducts are in good condition. No measures are required. Cleanliness and maintenance condition are excellent (see Figure 235).

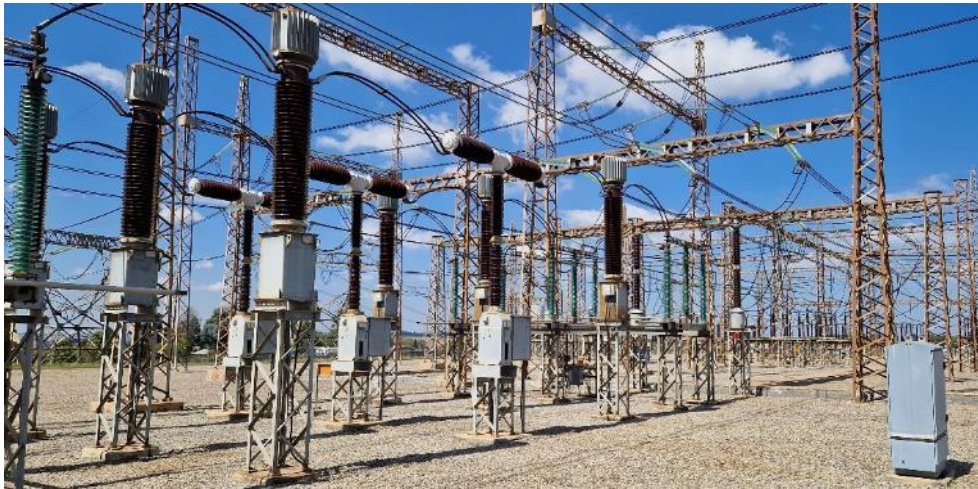
Figure 236: 275 kV switchgear substation Minerva

The Minerva substation was commissioned in 1977. During the years of operation, essential components such as power transformers, circuit breakers, instrument transformers and disconnectors were gradually replaced. The last modernisation measure was carried out in 2010 as part of an expansion of the switchgear for the connection of new overhead lines. De-

spite 46 years of operation, the substation is in a very good condition (see, for example, Figure 236). This is due to the permanent renewal of worn components and excellent maintenance of all substation components. Accordingly, the substation can continue to operate safely for several years if the current strategy is continued by replacing worn parts and intensively maintaining all components. The total evaluation results in an AC 1,45 (see Figure 237).

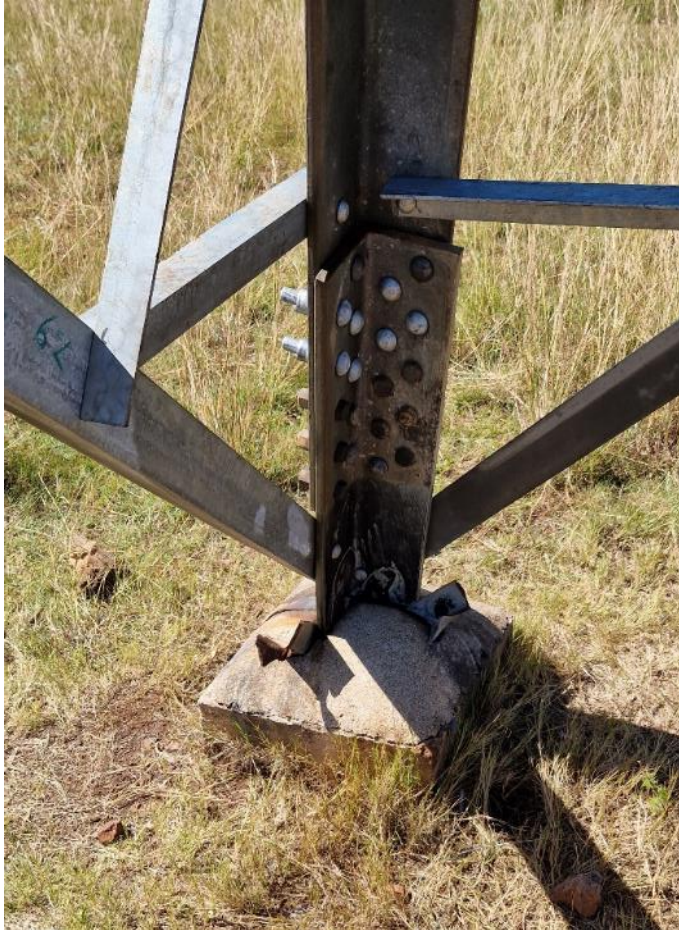
Figure 238: Tower 1APO/THU013

Activity class of tower 1APO/THU013, classification 2: Age-related wear and tear, no measures required (see Figure 238).

- Basements, AC classification 2 – Age-related wear and tear, no measures required.
- Steel construction, AC classification 2 – Age-related wear and tear, no measures required.
- Coating, AC classification 2 – Age-related wear and tear, no measures required.
- Groundings, AC classification 2 – Age-related wear and tear, no measures required.

The mast is in good condition. Age-related wear and tear are visible but does not impair the function. Damage caused by vandalism has been professionally repaired and preventive measures taken to avoid further damage (see Figure 239).

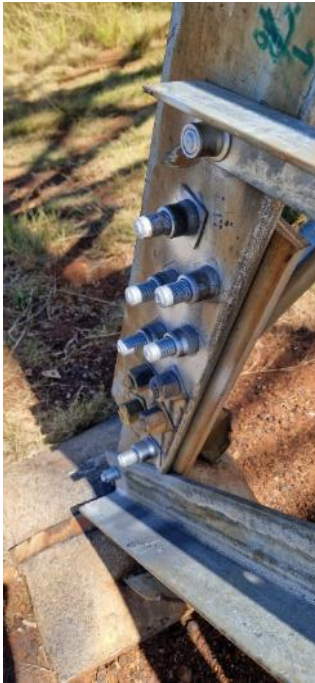
Figure 240: Self-locking nuts to avoid steel theft tower 1APO/THU013.

Activity class of security tower 1APO/THU013, classification 2 – Age-related wear and tear, no measures required (see Figure 240).

- Prevention of unauthorised climb up, AC classification 2 – Age-related wear and tear, no measures required.
- Prevention of vandalism, AC classification 2 – Age-related wear and tear, no measures required.

Climbing prevention measures are installed to prevent unauthorised climbing. Self-locking nuts used for bolting at the base of the towers to prevent steel theft. These measures should provide sufficient protection against further damage caused by vandalism (see Figure 241).

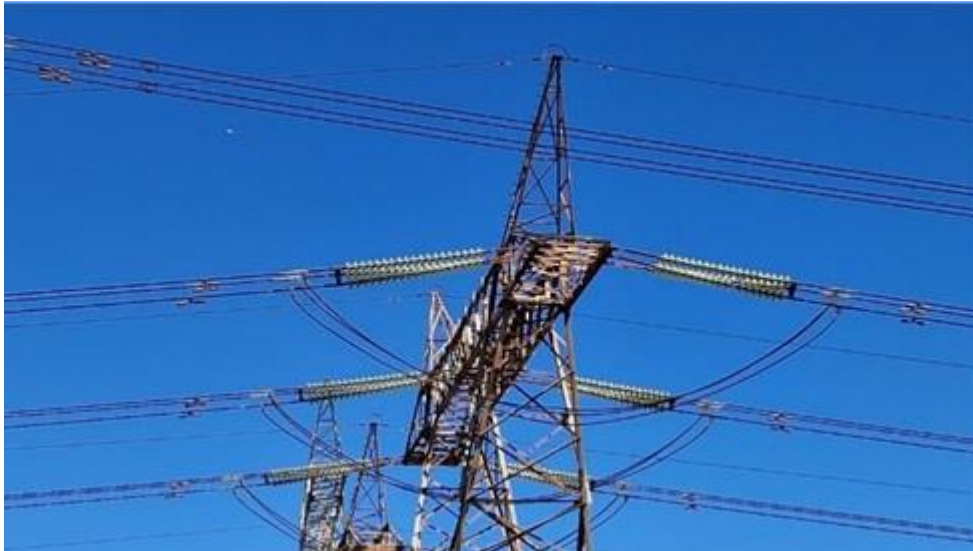
Figure 242: Insulation chains of 400 kV OHL

Activity class of insulation chains tower 1APO/THU013, classification 1 – condition without findings (see Figure 242).

- General condition, AC classification 1 – condition without findings
- Cleanness, AC classification 1 – condition without findings
- Glass cups condition, AC classification 1 – condition without findings

The glass cap insulating chains were visually inspected from the ground for the inspected OHL and the parallel OHL. The condition was perfect (see Figure 243).

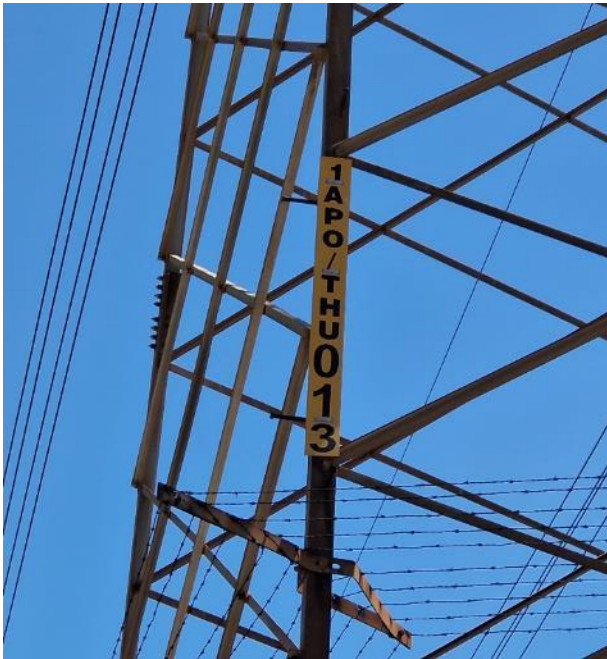
Figure 244: Marking of tower 1APO/THU013.

Activity class of marking OHL tower 1APO/THU013, classification 1 – condition without findings (see Figure 244).

- Label condition, AC classification 1 – condition without findings
- Name of line, AC classification 1 – condition without findings
- Number of towers, AC classification 1 – condition without findings

The marking of the tower was visually inspected. The condition was perfect (see Figure 245).
